Brightech Property Inspections

Confidential - Home Inspection Report - Confidential

123 Maine Street, Cape Elizabeth, ME 04107
Inspection prepared for: Jane Doe
Real Estate Agent: Realtor -

Date of Inspection: 8/1/2014

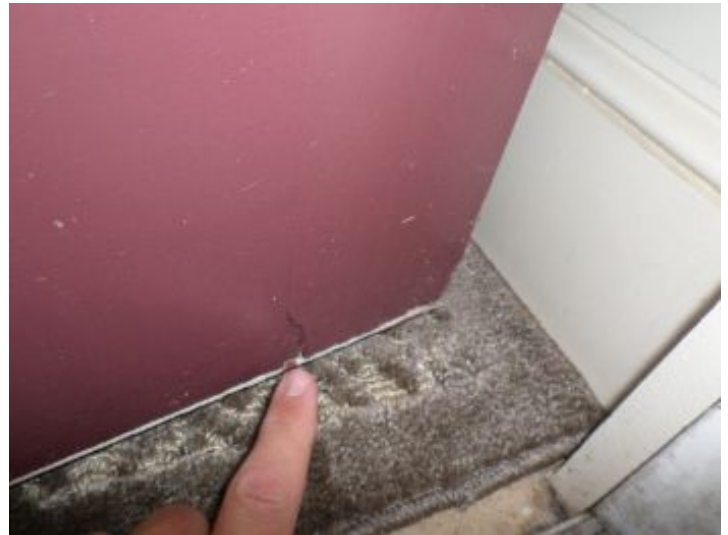
Note: Door damage on siding door.

Wood rot was observed at the bottom of the front exterior door. Consider budgeting in upgrading the exterior doors. Also, once consider installing a storm door to help with heating/cooling costs

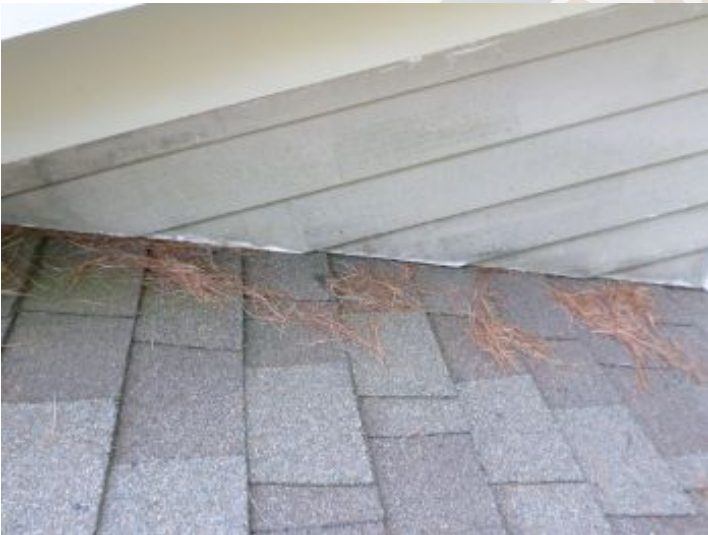
Observed that the siding was too close to the roof covering. Wooden siding adjacent to the roof surface should have at least an inch of clearance from the roof covering (and more in snowfall areas)

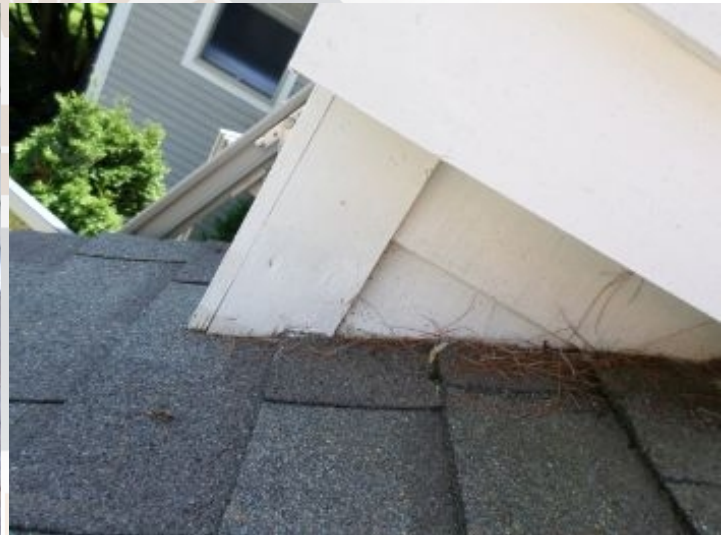
Note: Siding was too close to roof coving.

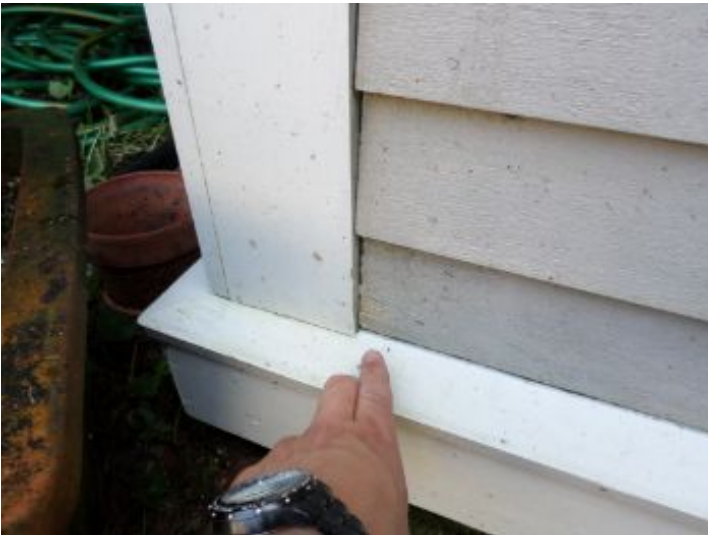
Softening wood was observed.

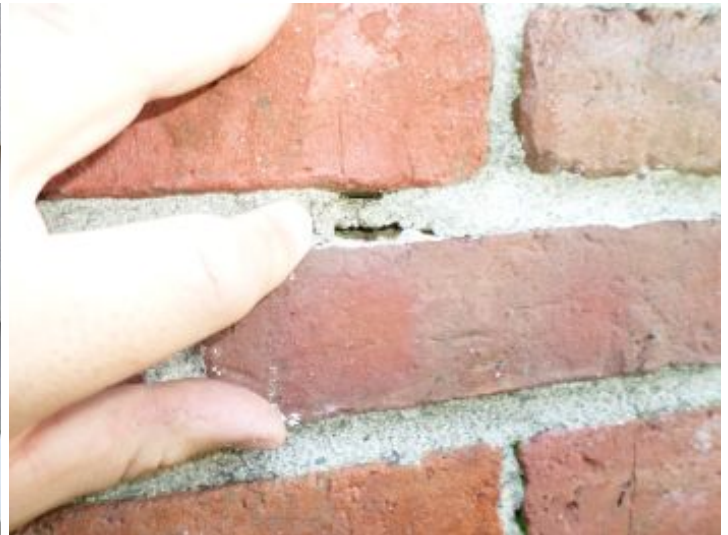
Repointing of the bricks would be recommended in the next few years.

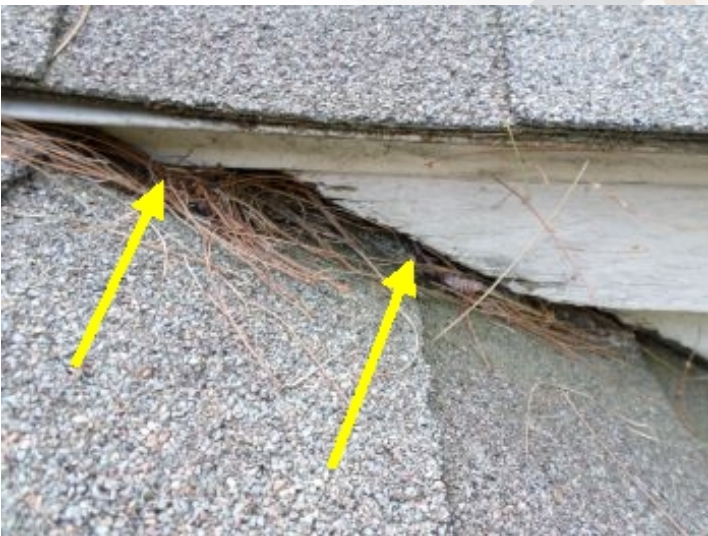
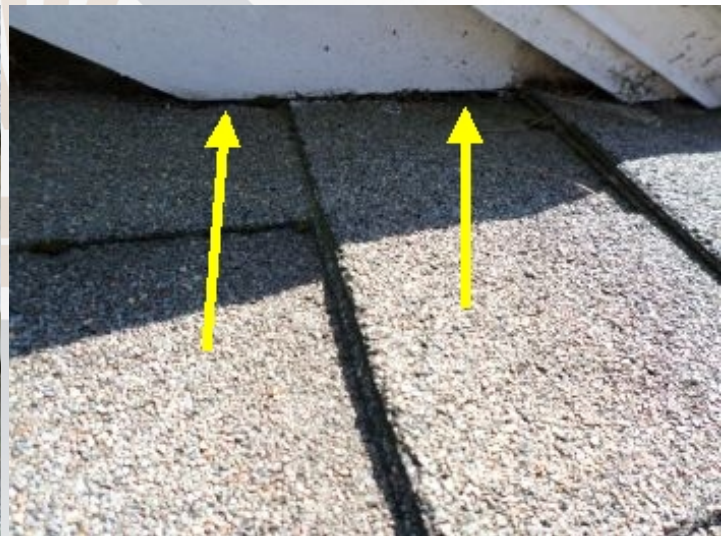
Wood rot observed. Wooden trim adjacent to the roof surface should have at least an inch of clearance from the roof covering (and more in snowfall areas) This leads to the wood wicking the water and rot.

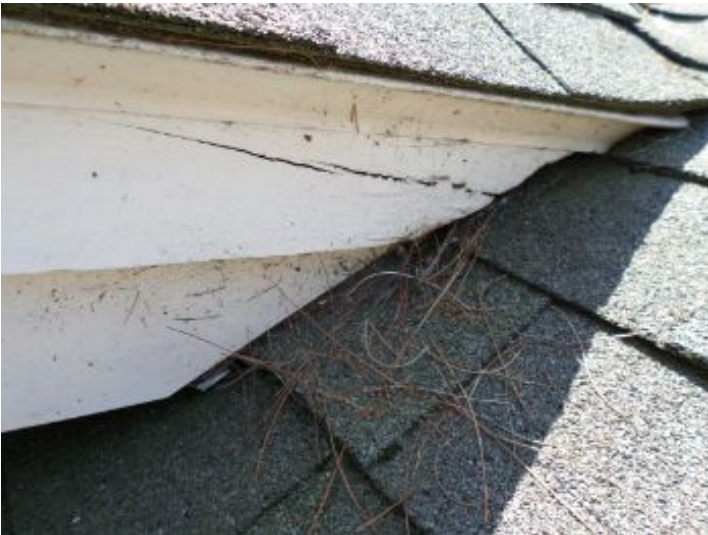
Wood rot noted. Recommend contacting a qualified general contractor to make necessary repairs.

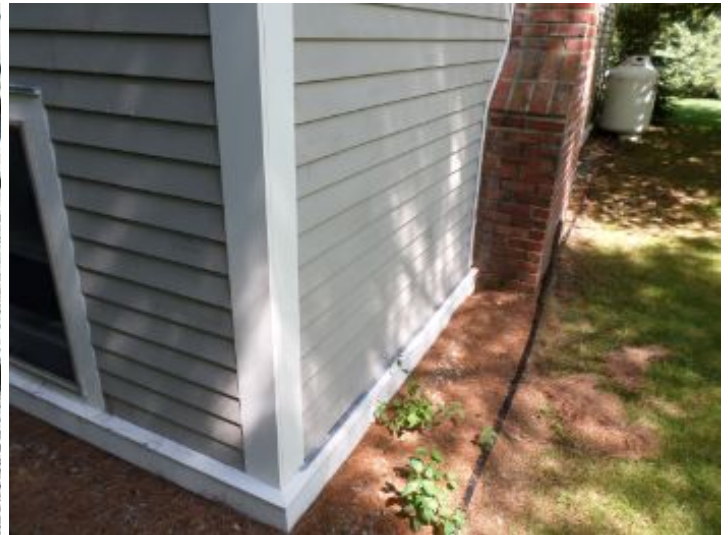
Observed wood trim in contact with the ground. This will lead to premature wood rot, due to moisture wicking. Contact a qualified contractor to make necessary repairs. Please see graphic

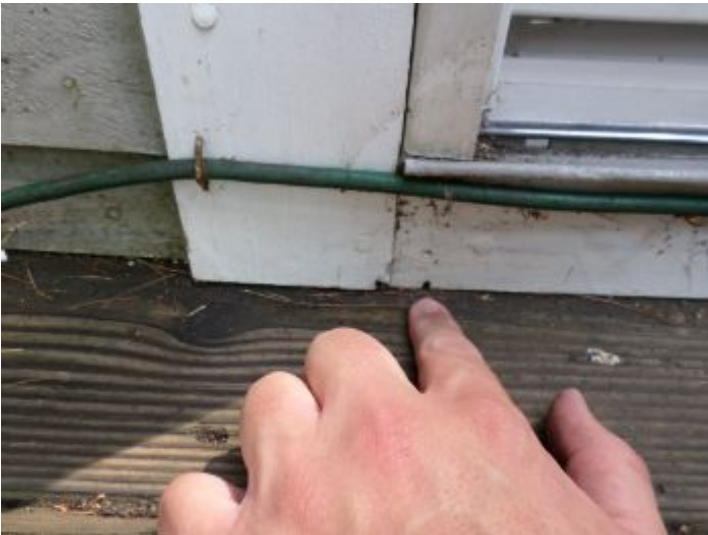
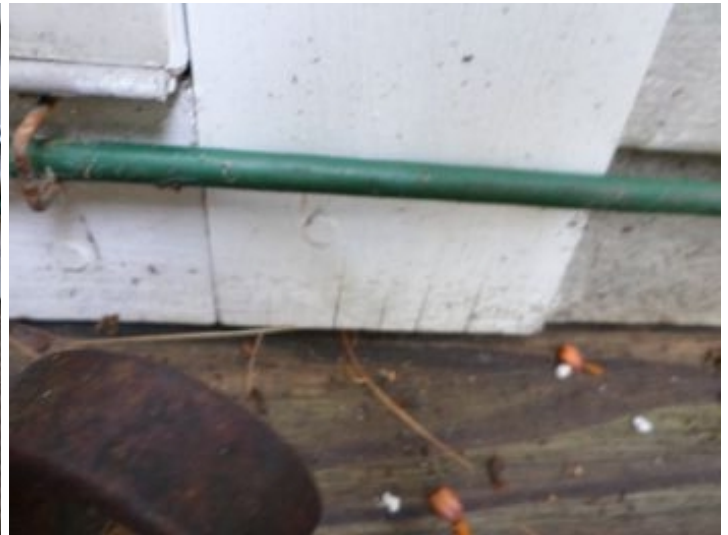
Note: Wood softening was observed.

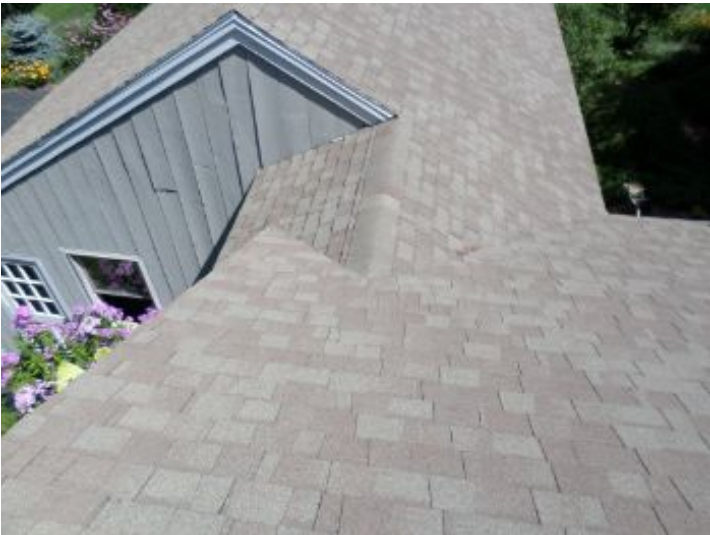
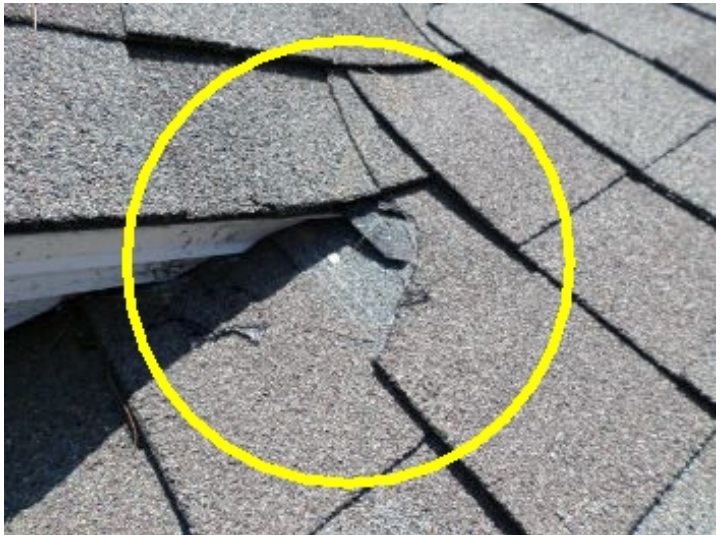
Observed damage to the roof covering. This may be caused by an uplift from the wind. Recommend contacting a qualified roofing contractor to make necessary repairs.

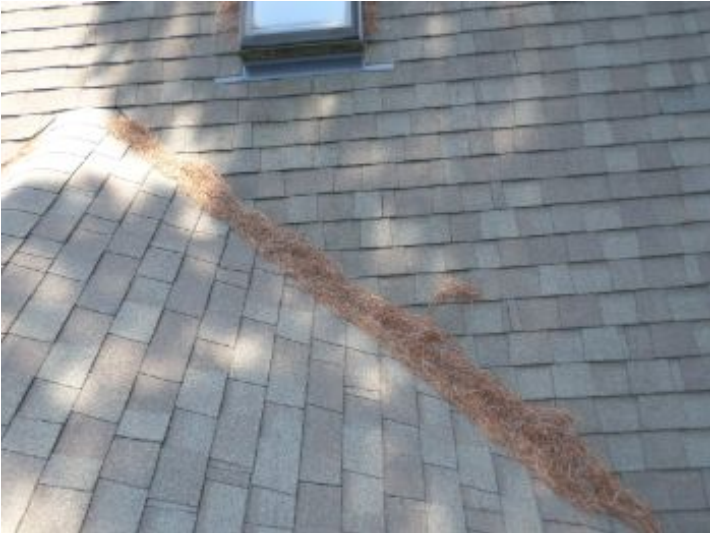
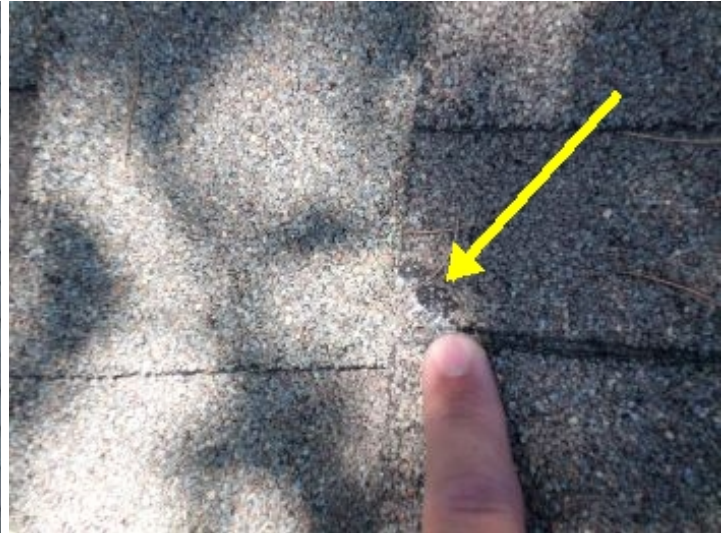
Note: observed high amounts of pine needles on various parts of the roof. This can hold moisture and lead the plant growth that could possibly damaged the roof covering.

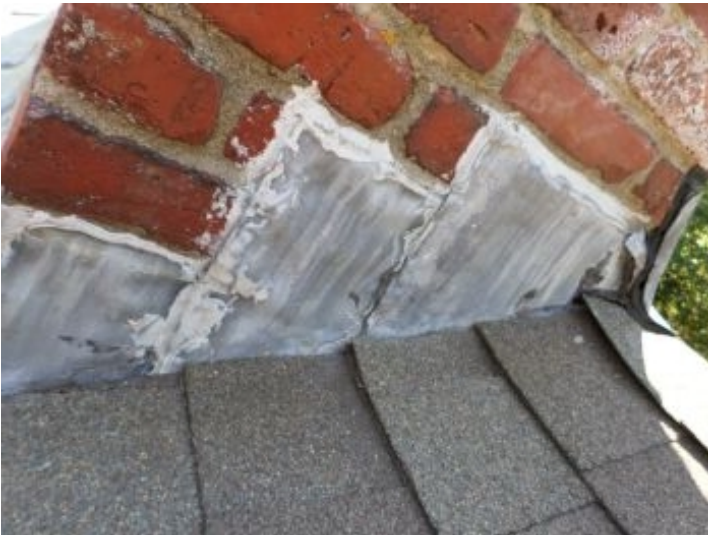
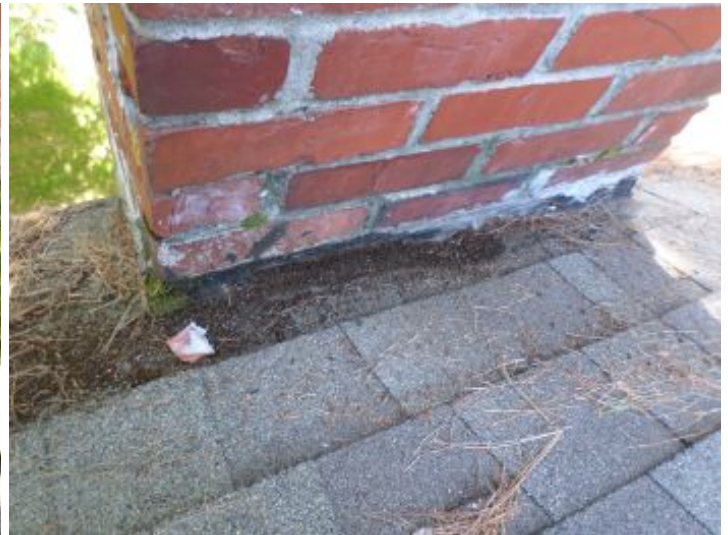
Note: (I cleared away a good amount of the needles) Large amounts of pine needles were gathering behind head flashing. Because of the moisture being held, moss and other plants were seen growing.

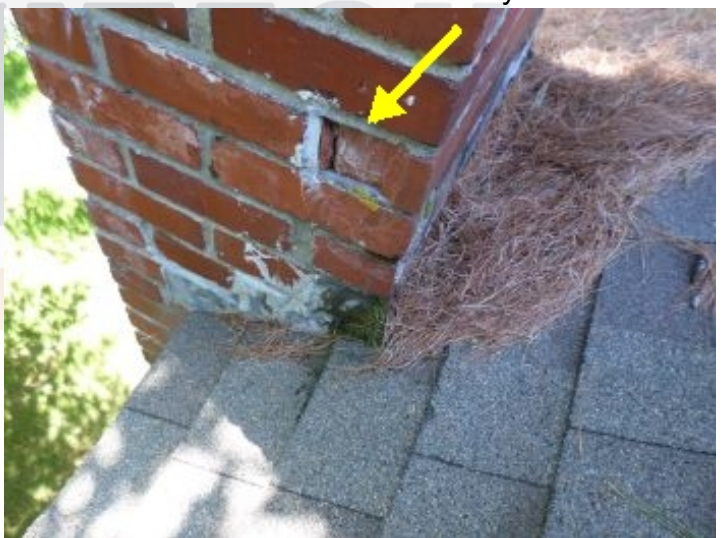
Note: Spalling was observed.

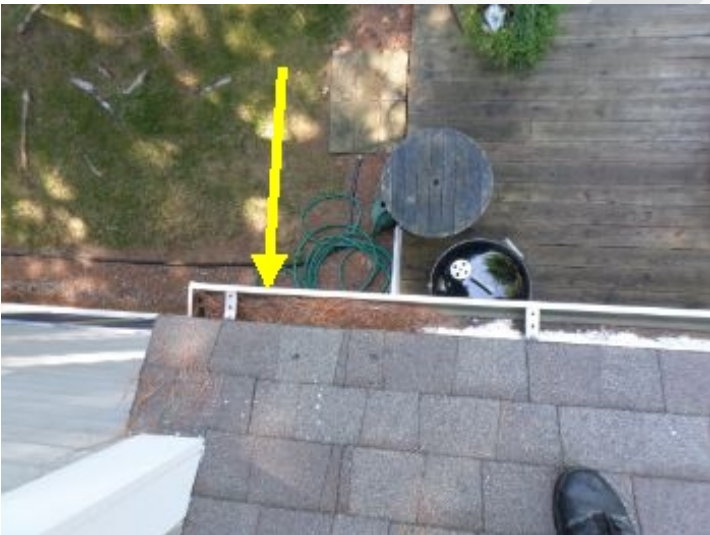
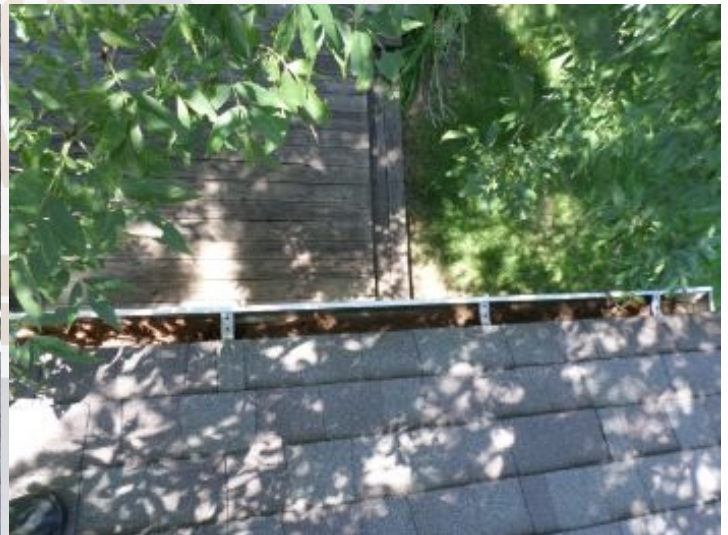
Note: observed that the roof drainage system is full of debris, recommend having the gutters cleaned quarterly.

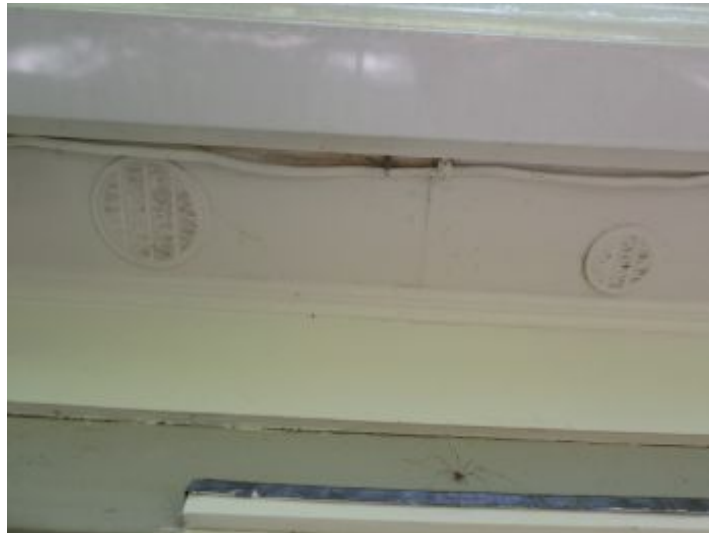
Observed that many of the soffit vents were painted over blocking most of the ventilation. Recommend replacing painted over vents with new unpainted vents. They should be readily available at most home centers.

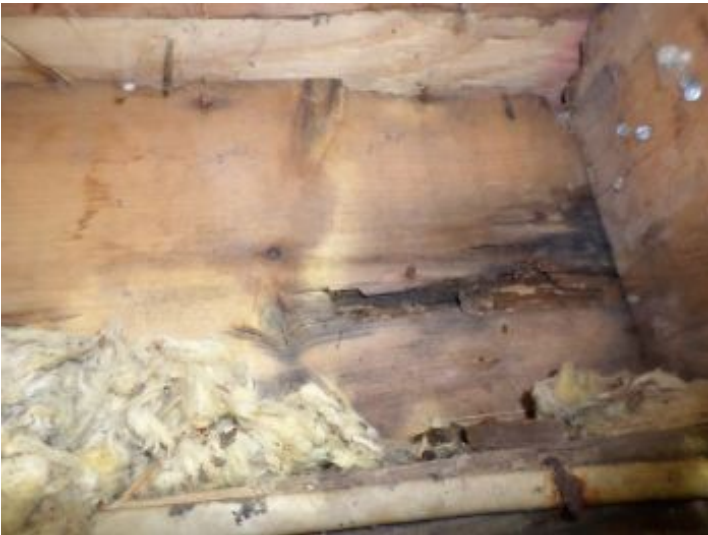
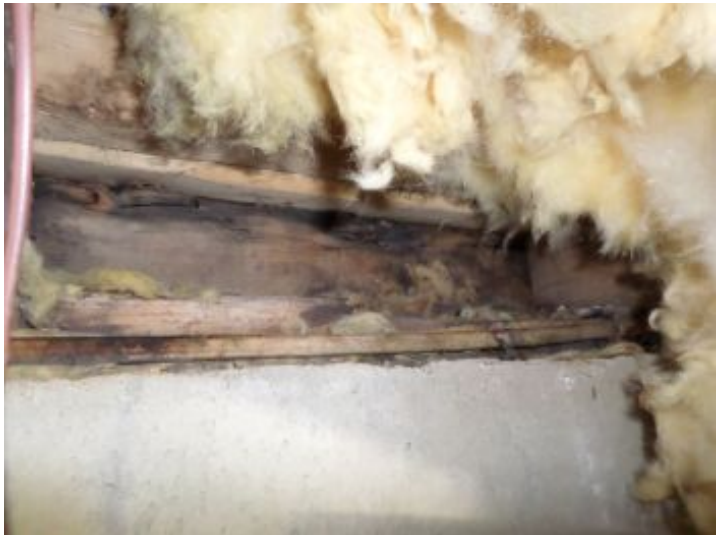
(From Crawlspace) Observed a major amount of wood rot and deterioration on the rim joists that abuts the exterior deck ledger. This is due to not having proper flashing installed on the exterior.
 Contact a qualified contractor to make the necessary repairs. (This will be a large project It could become costly)

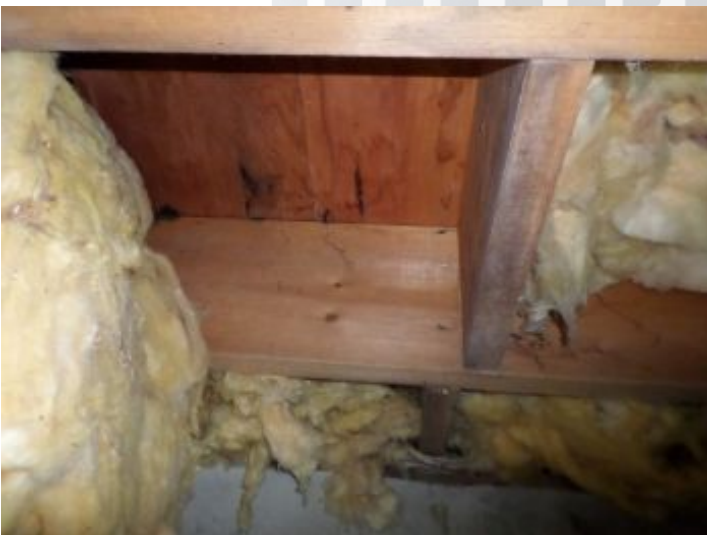
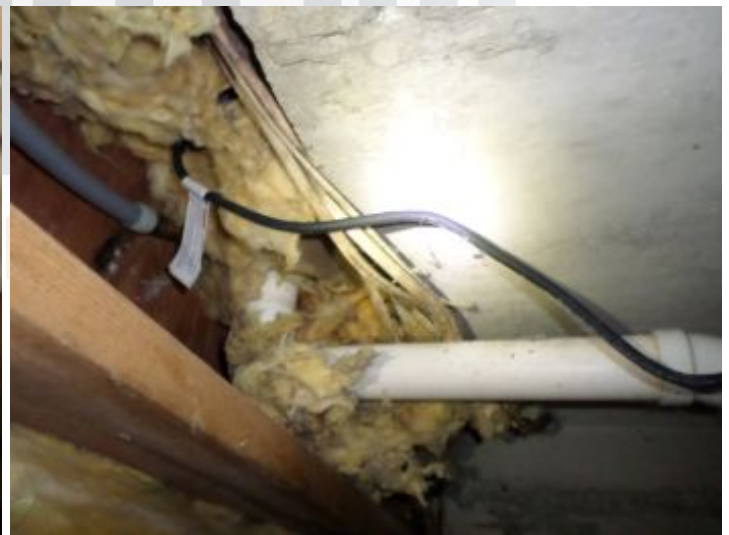
Observed many areas of insulation voids. Recommend reinstalling/replacing insulation. This will help control energy costs.

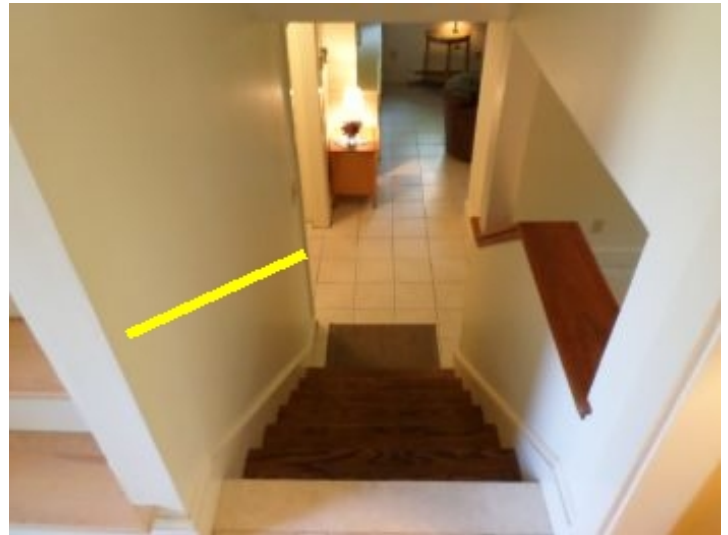
Note: Today's standards really is height should be between 34 inches and 38 inches Consider installing a railing for safety concerns.

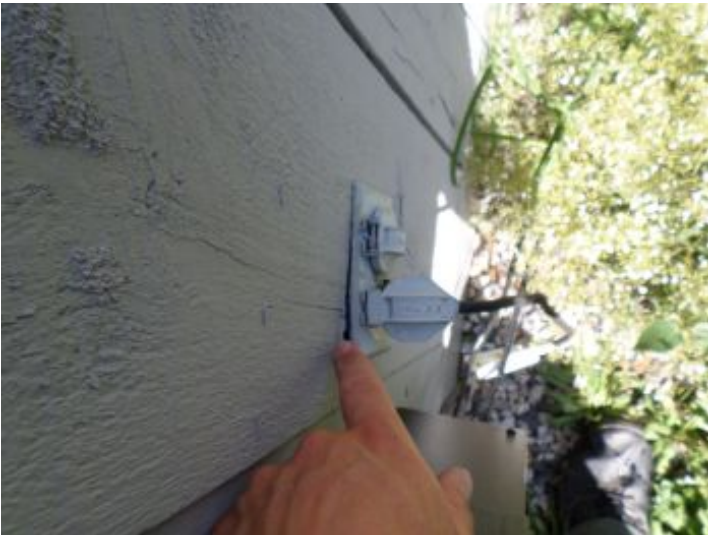
Observed the exterior Garage electrical outlet to be very loose, Also did not appear to be GFCI as required in today's standards. Contact a licensed electrician to make the necessary repairs

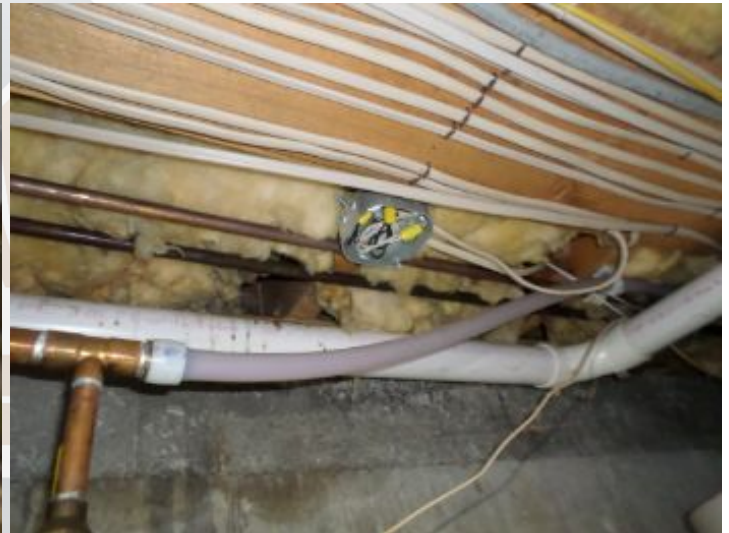
Observed an open junction box under the crawlspace area. For safety reasons have a new cover installed over the box.

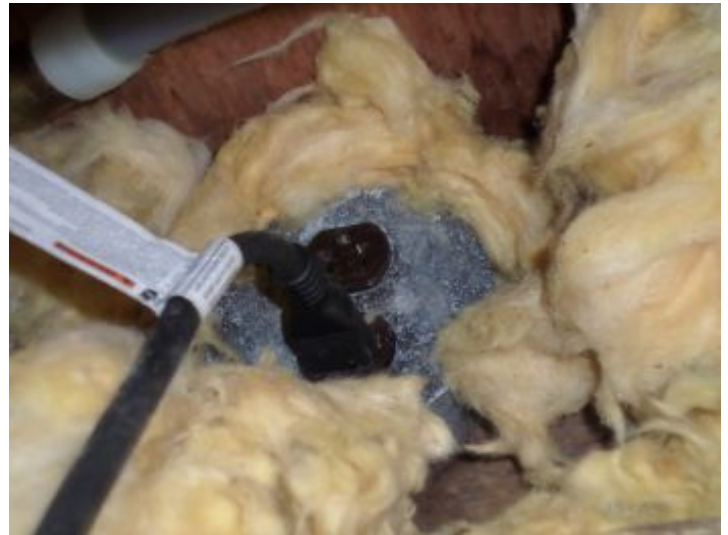
Observed the outlet that supplies energy for the sump pump is not a GFCI. This is a safety concern, since it has direct access to water.

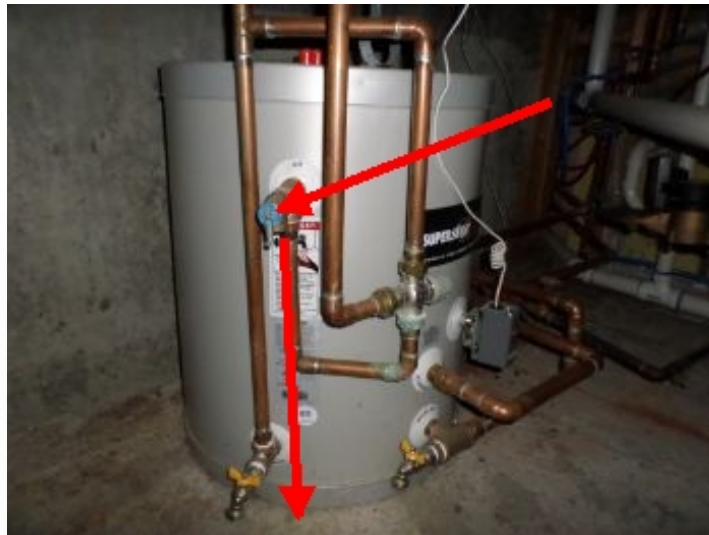
Safety Concern. TPRV does not properly terminate at or below 6 inches from ground level. This lessens the chance of scalding, if the discharge ever happens as most of the hot water will be discharging directly to the floor.

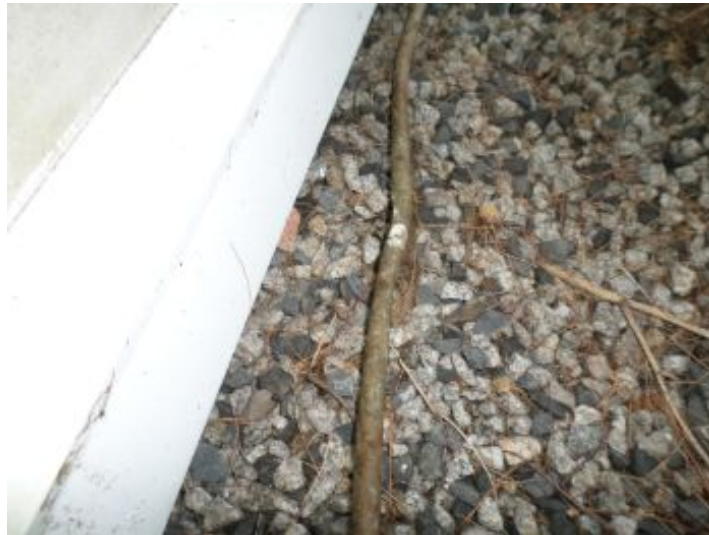
Recommend upgrading copper propane lines as they appear to be in poor shape. There are many dents and kinks in the line. Consider upgrading to a protected piping that is not installed on the ground level.

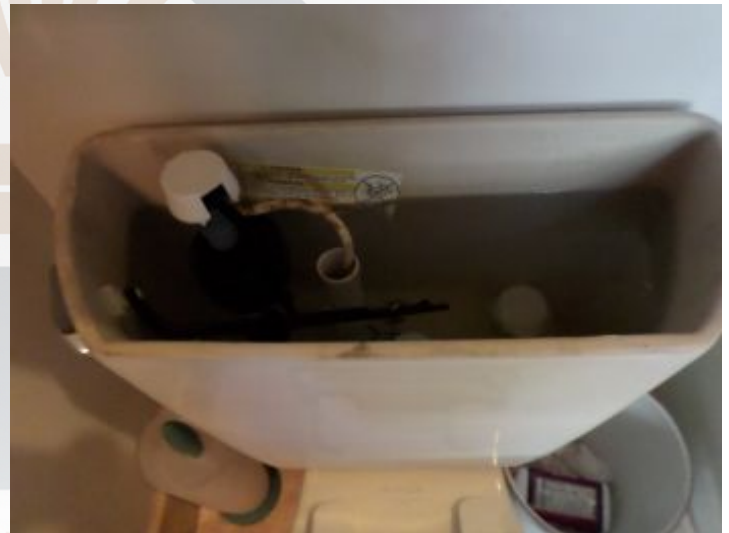
The top tank on the toilet was a bit loose, re-tighten is necessary

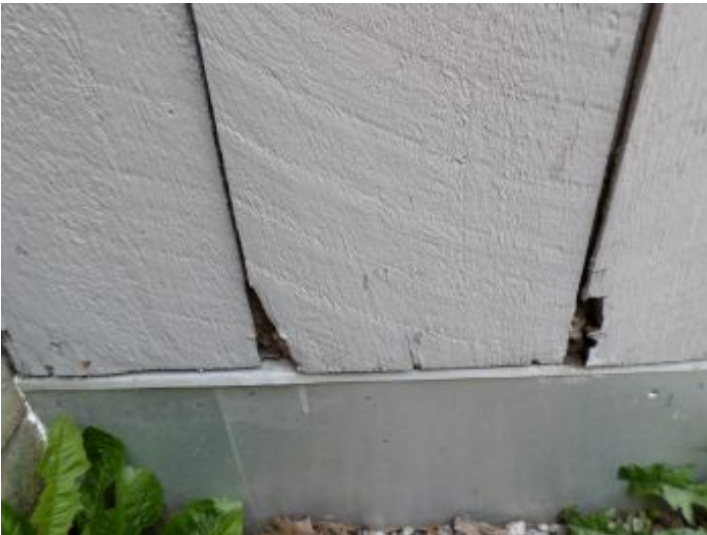
Observed a few areas of the garage siding that is showing signs of aging. Consider budgeting and replacement siding for the garage future.

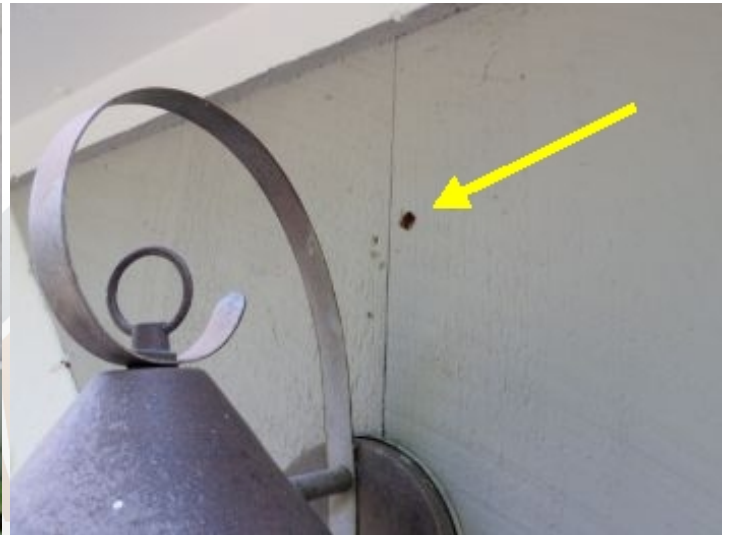
Small hole was observed in the garage. Recommend sealing with silicone caulking

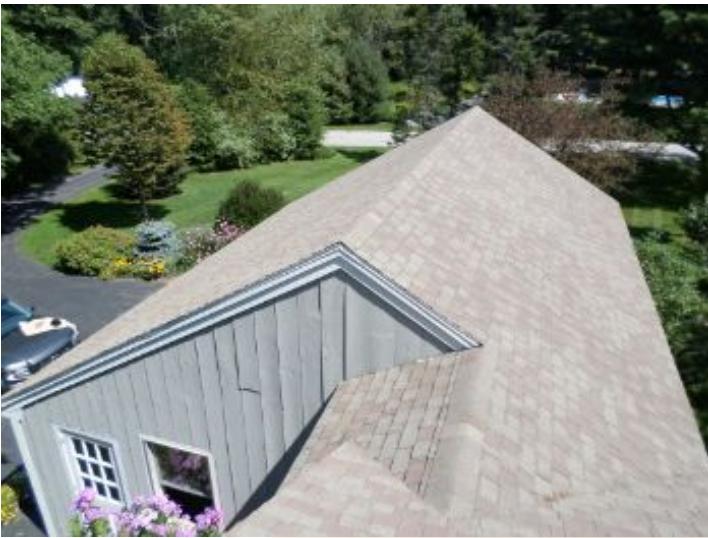
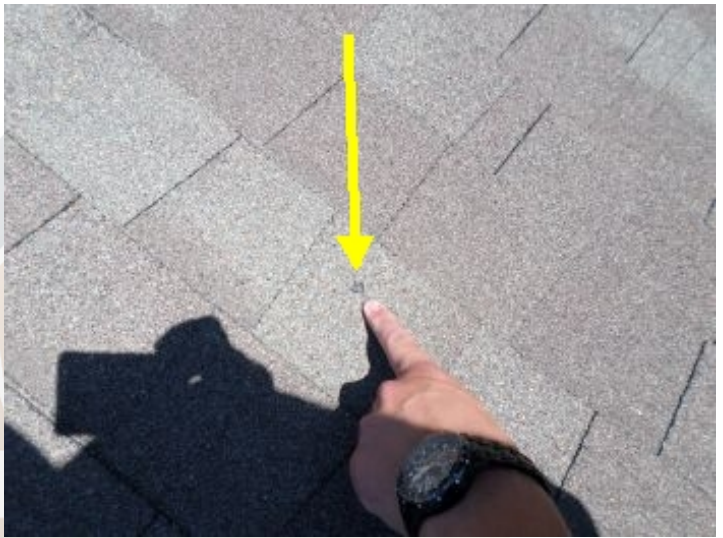
Note: Roof covering damage was observed.

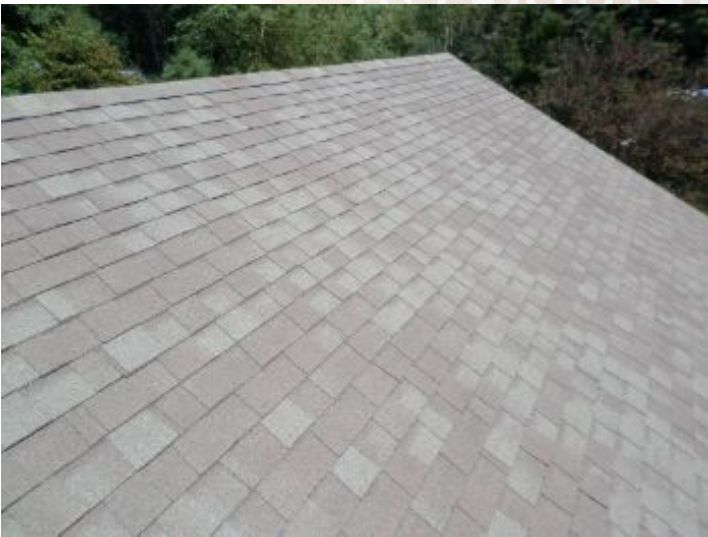
Note: Roof covering damage was observed.

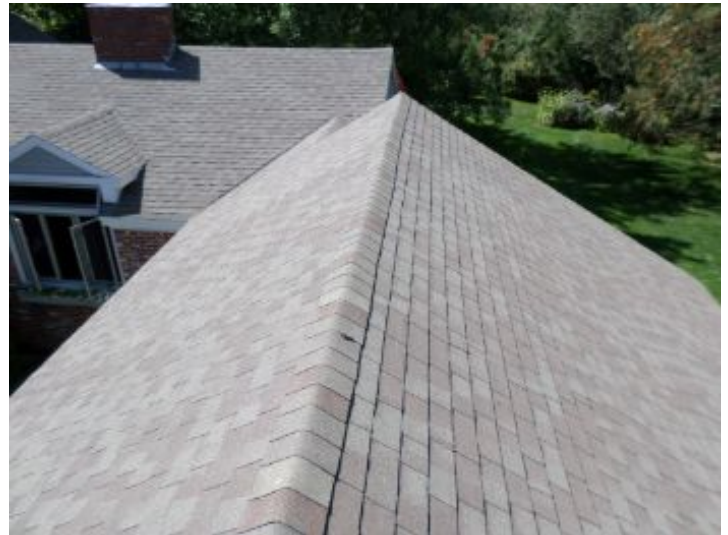
Note: deterioration of the roof covering observed.
