Brightech Property Inspections

Confidential - Home Inspection Report - Confidential

123 Maine Street, Cape Elizabeth, ME 04107
Inspection prepared for: Jane Doe
Real Estate Agent: Realtor -

Date of Inspection: 8/1/2014

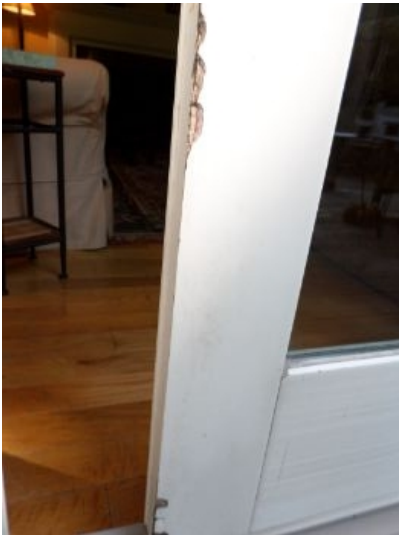
Note: Door damage on siding door.

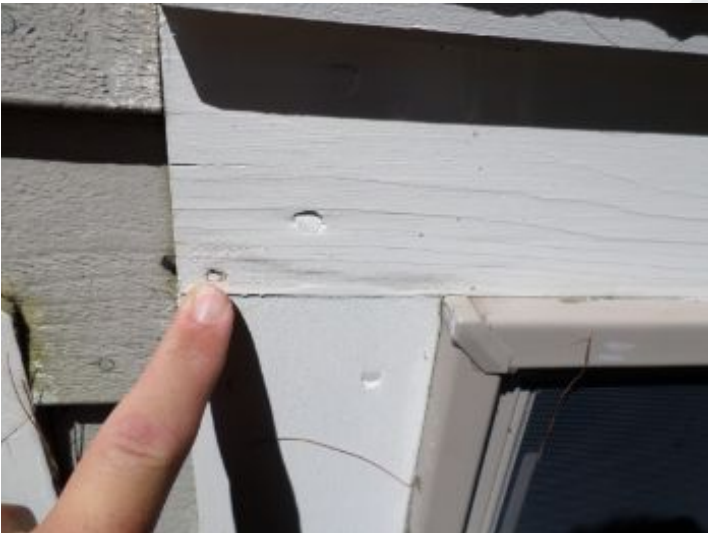
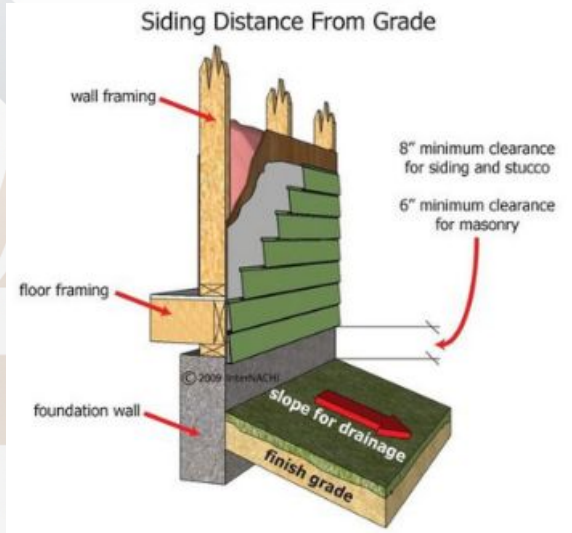
Observed wood trim in contact with the ground. This will lead to premature wood rot, due to moisture wicking. Contact a qualified contractor to make necessary repairs. Please see graphic

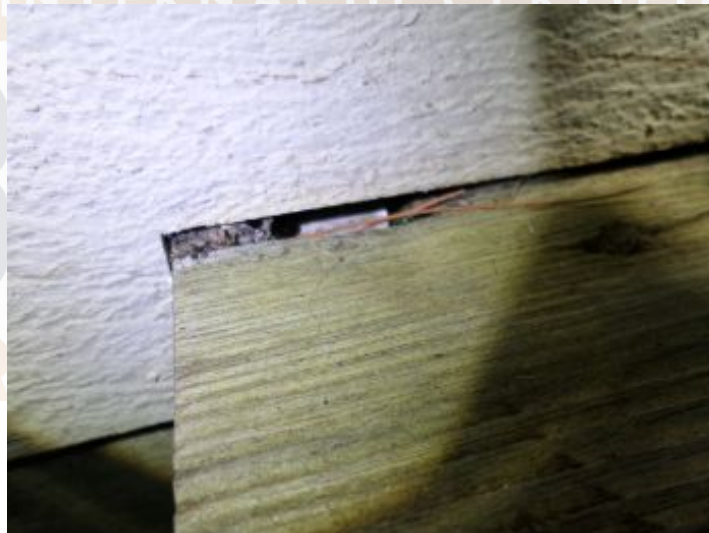
- No flashing present.

Note: It appeared that there is no flashing installed the deck Ledger attachment to the structure.

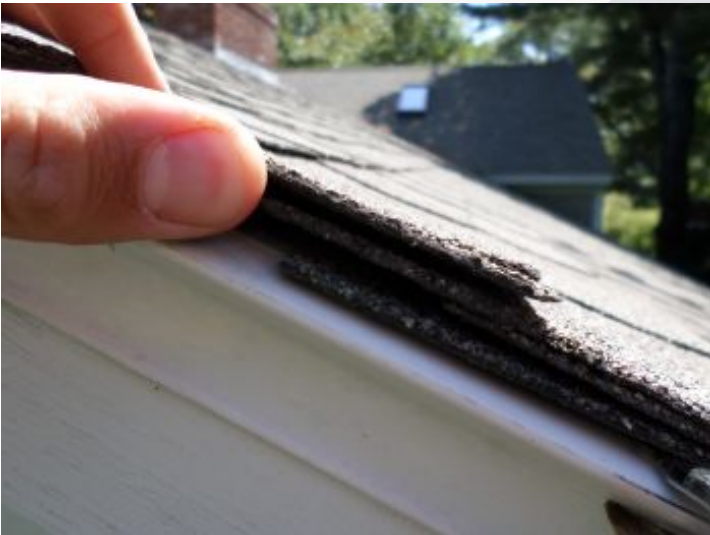
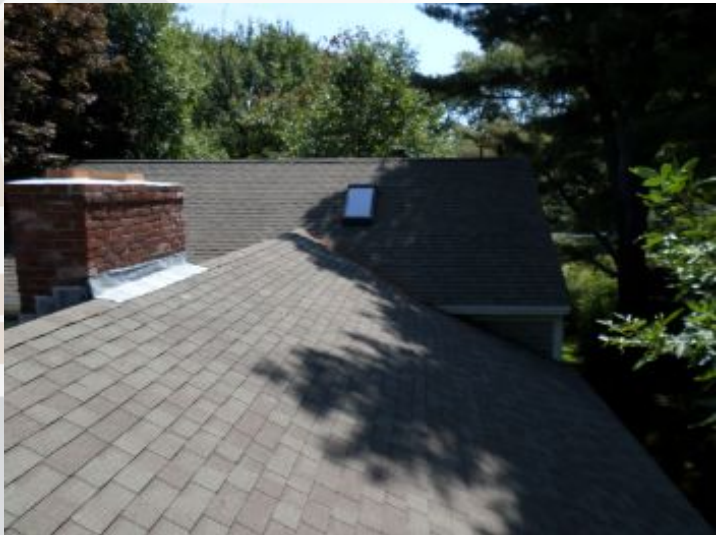
- Minor algae staining observed on northern side of the roof areas.
- Damage was observed

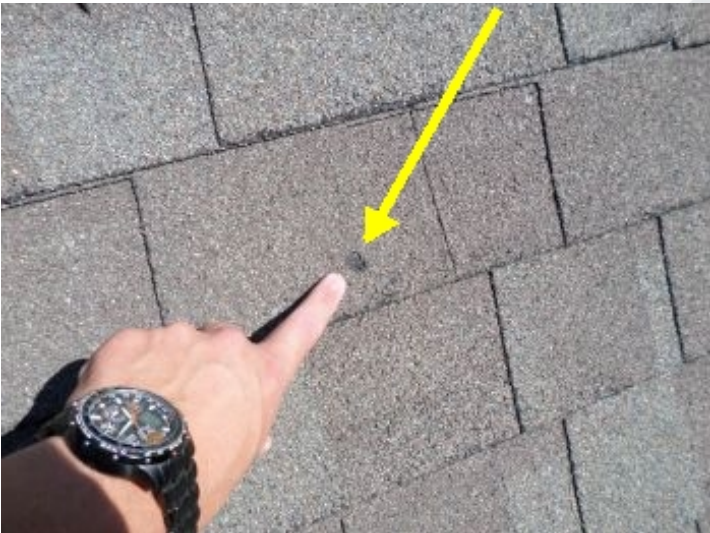
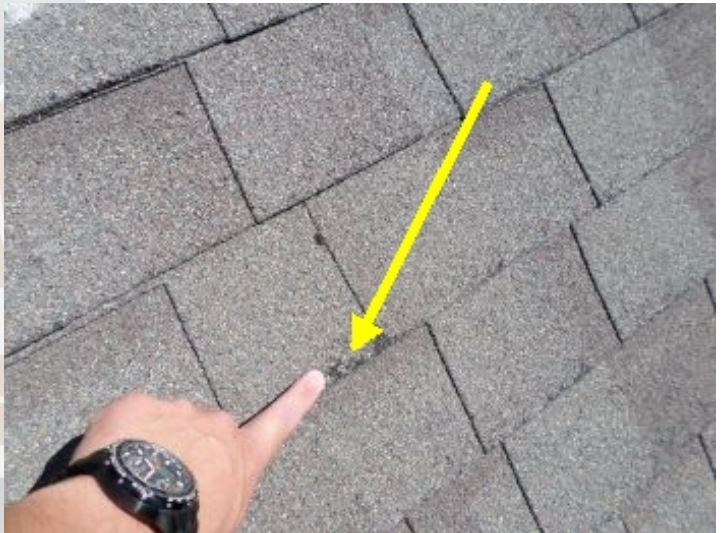
Observed damage to the roof covering. This may be caused by an uplift from the wind. Recommend contacting a qualified roofing contractor to make necessary repairs.

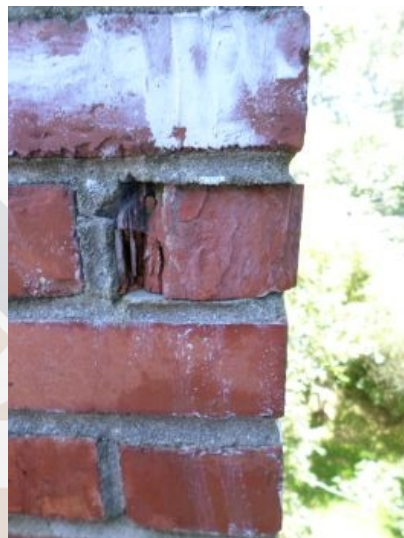
Observed deterioration (spalling) of the bricks on the Southside chimney.

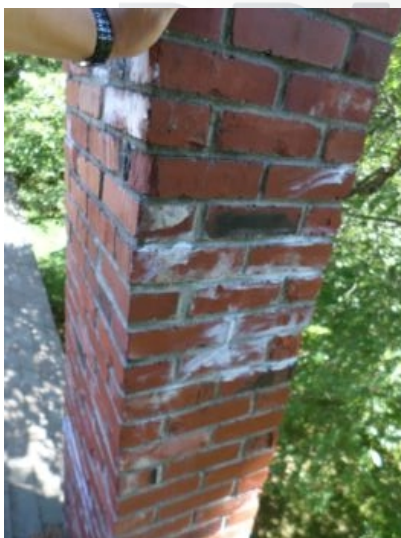
Observed what appeared to be some sort of silicone caulking smeared into the mortar joints.

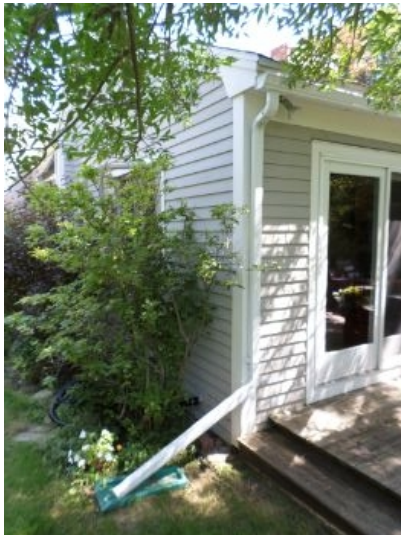
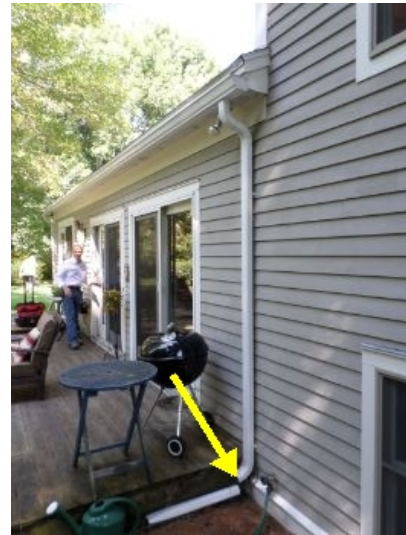
Note: observed that the roof drainage system is full of debris, recommend having the gutters cleaned quarterly.

Recommend reattaching downspout So that it terminates 6 to 8 feet away from the building's foundation.

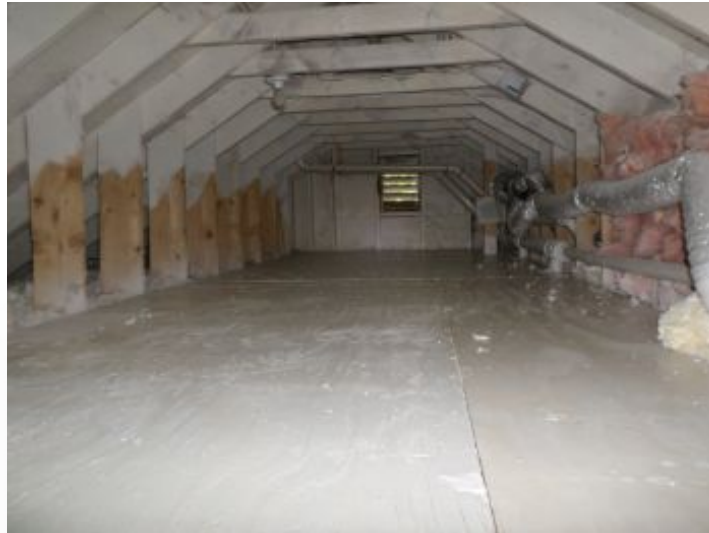
Observations: IMPROVE: The attic access is not properly insulated. Expect some energy loss through convection. Recommend insulating attic access hatch cover with a batt of fiberglass insulation to reduce energy expenses. • It appeared that the attic space has recently had remediation. Recommend asking the current owner for more details of this action, such as: what company performed the attic remediation and when did the work take place.

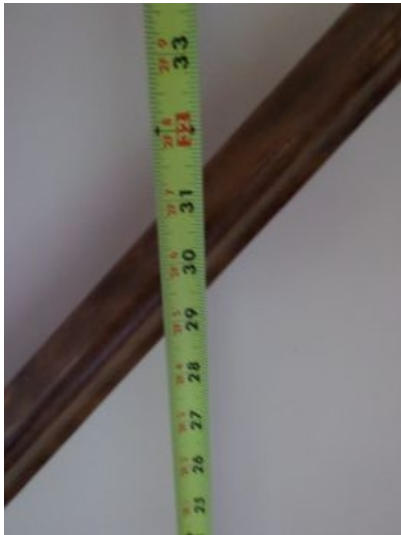
- recommend hand rails

Note: Today's standards really is height should be between 34 inches and 38 inches Consider installing a railing for safety concerns.

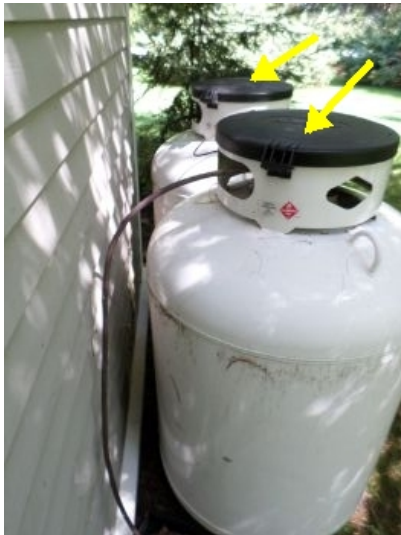
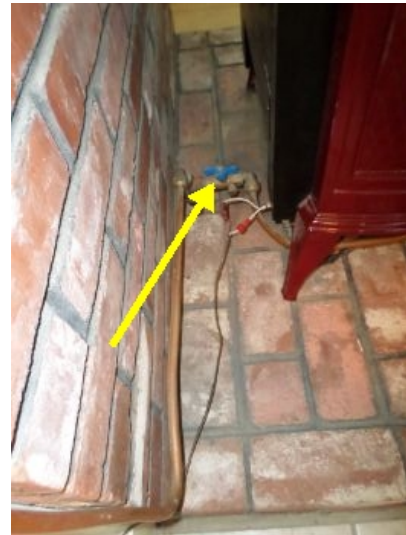
Gas Stove shut off.

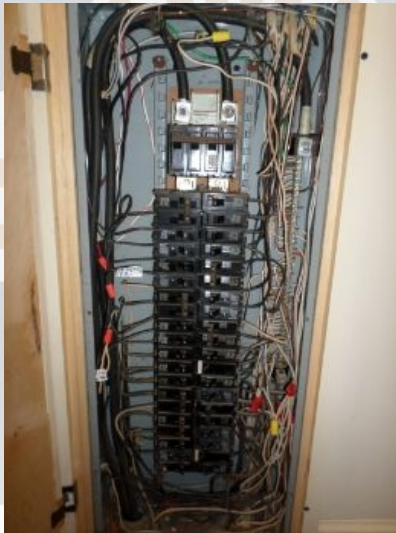
• Neutral wires are doubled or bundled together on the neutral bus bar. Although common practice in the past, this is unsafe due to the need to turn off multiple circuit breakers to work on any of the circuits using these wires. Also there is a great chance that they could become loose and start to arch. This could become a fire hazard. Qualified electrician should evaluate and repair as necessary.

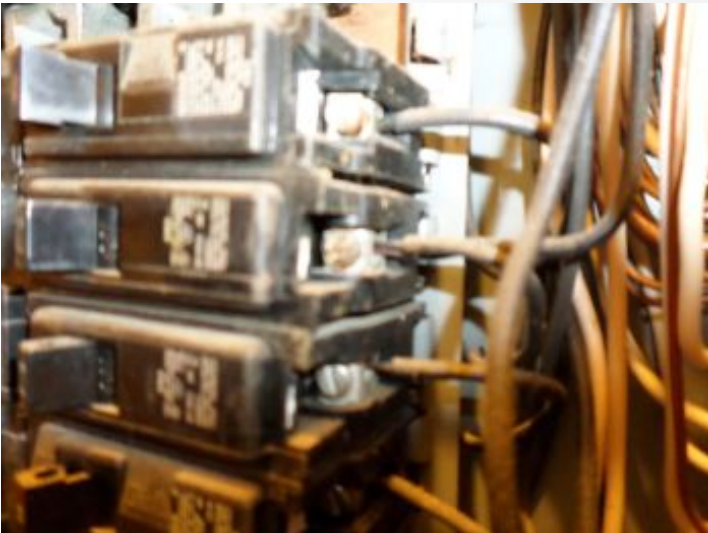
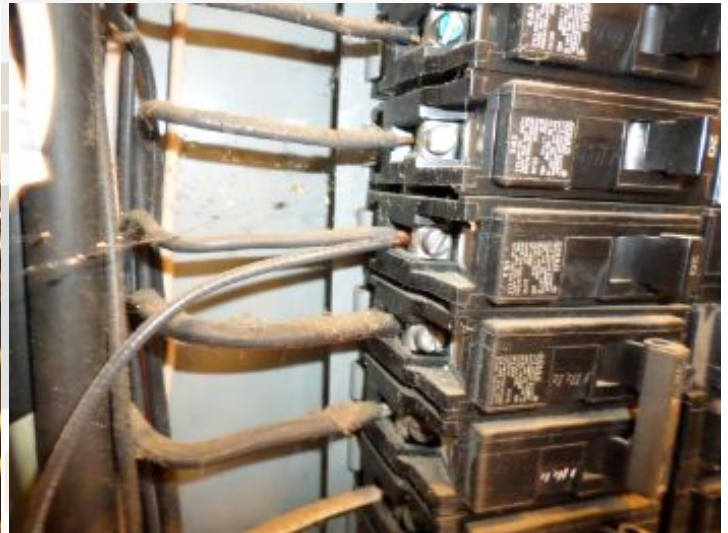
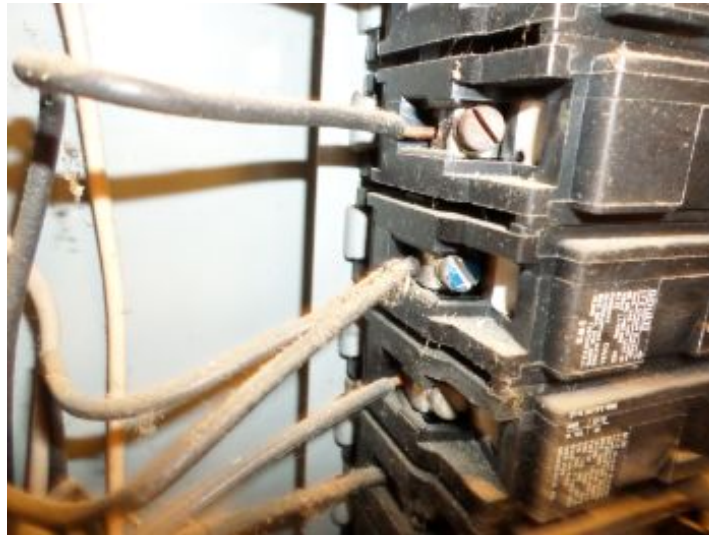
- (Safety Concern) There are breakers/fuses that are "Double Tapped" -- where 2 or more wires are clamped in a terminal designed for only one wire. This is a safety hazard since the bolt or screw may tighten securely against one wire, but leave the others loose. Arcing, sparks and fires may result. A qualified electrician should evaluate and repair as necessary.

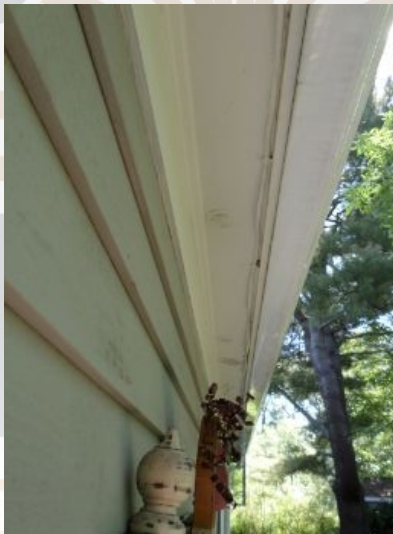
- Romex wiring is susceptible to damage & should be protected. Location:soffit near deck. The wiring needs protective bushings were it enters the box. Recommend a licensed electrician properly protect the wiring.

(Safety Concern) NM wiring must be Protected with conduit. The plastic sheathing on this type of wire is not protected from abrasions or punctures. Recommend contacting a licensed electrician to make necessary repairs.

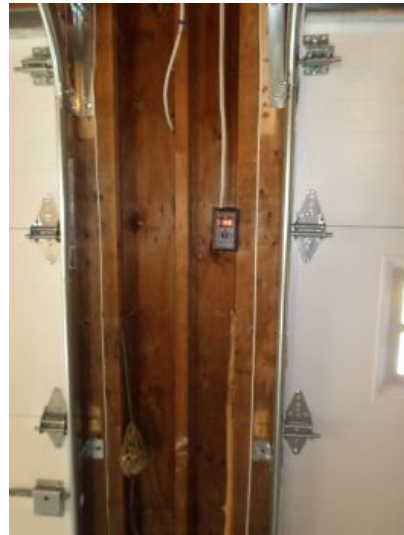
Observed the exterior Garage electrical outlet to be very loose, Also did not appear to be GFCI as required in today's standards. Contact a licensed electrician to make the necessary repairs

(Safety concerns) , consider installing a GFCI outlet in the garage, as this is today's standards for safety.

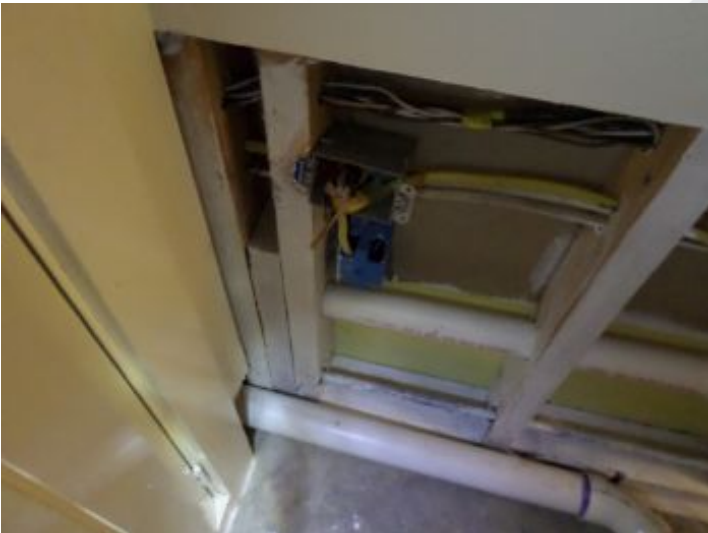
(Safety concern) observed in open junction box in the utility closet. Contact a licensed electrician to make the necessary repairs

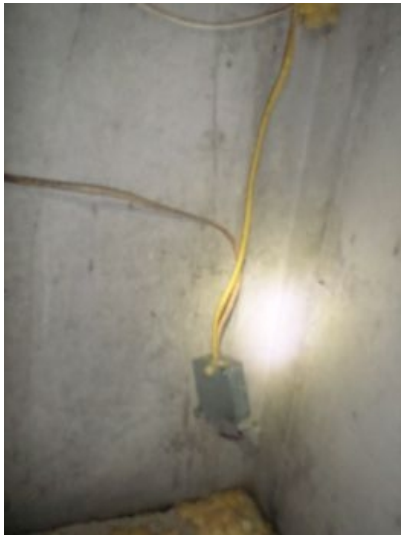
Observed in unsecure junction box under the crawlspace area. Recommend affixing it to the proper location

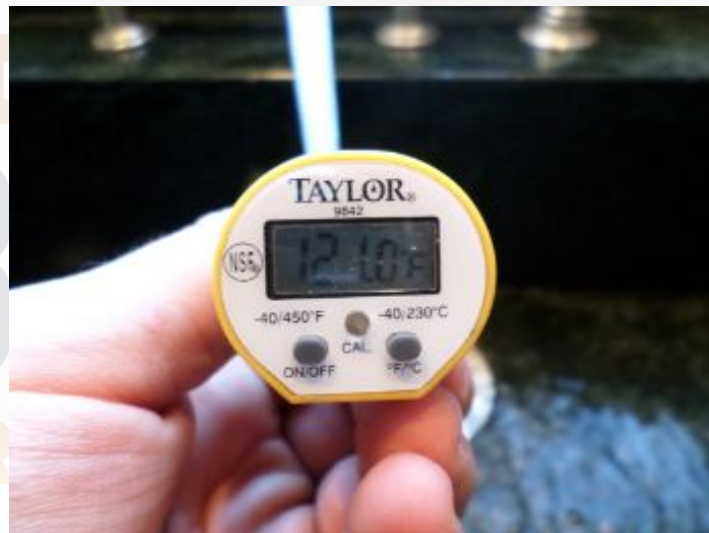
- (SAFETY CONCERN) Hot water was observed over 120 degrees. This is a scolding hazard.

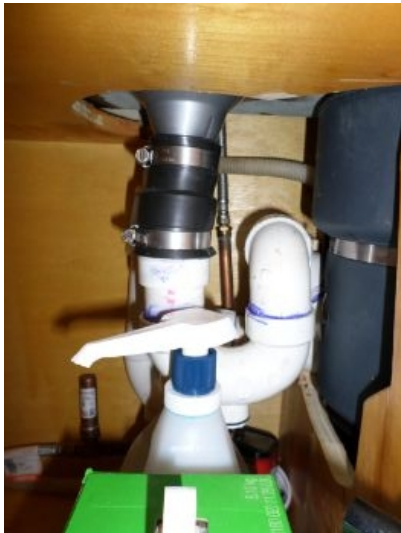
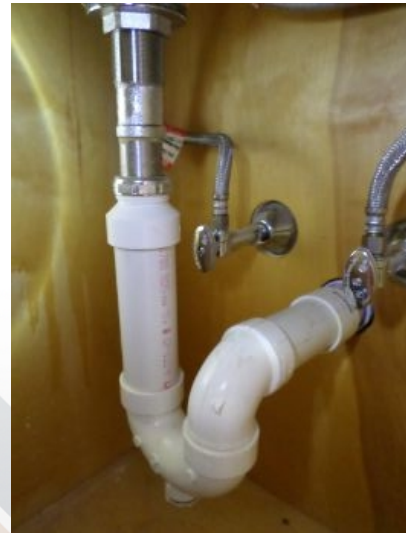
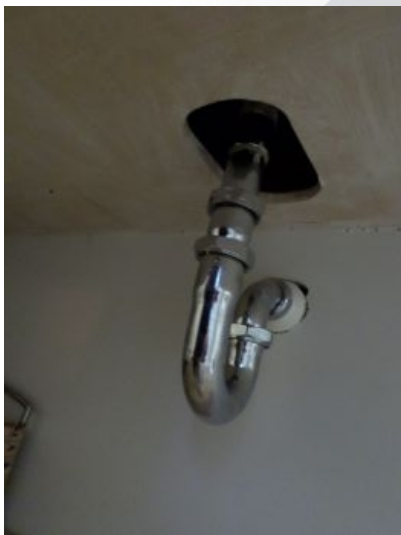
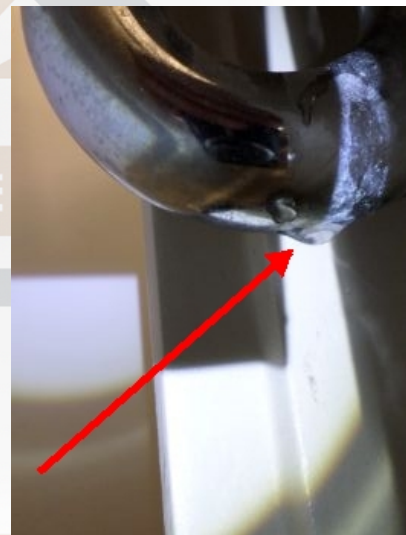
Observations:
 • Evidence of leak in basement bedroom sink drain trap. Repair as needed.

Observed an active water leak at the downstairs bathroom sink. Contact a licensed plumber to make the necessary repairs.

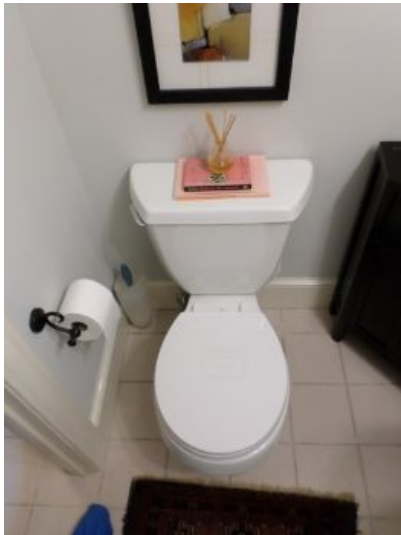
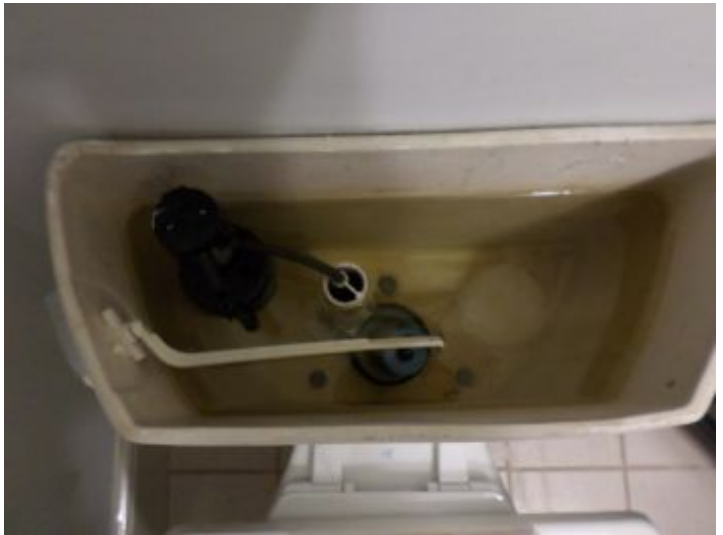
The top tank on the toilet was a bit loose, re-tighten is necessary

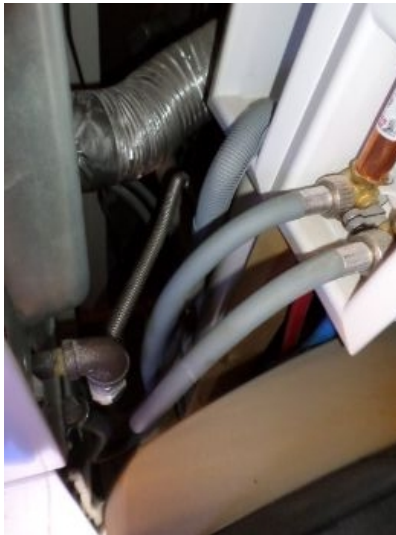
- IMPROVE: Highly recommend upgrading to the braided metal washing machine water supply hoses instead of the rubber ones--which are prone to burst. See example Photo.

Consider upgrading hoses connecting the wash machine to stainless steel braided lines that are less prone to bursting.

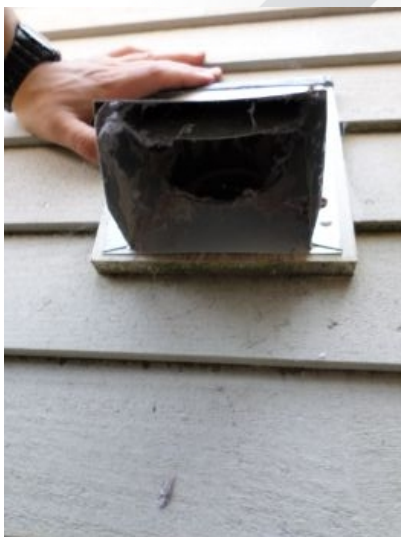
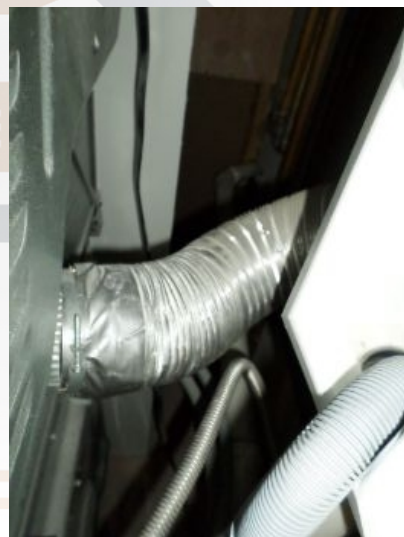
Observe the dryer vent is in need of cleaning. Also, the vent louver was stuck in the open position. This could lead to heat loss and a access for pests.

Consider upgrading the dryer vent to a rigid smooth type they are less prone to clogging.

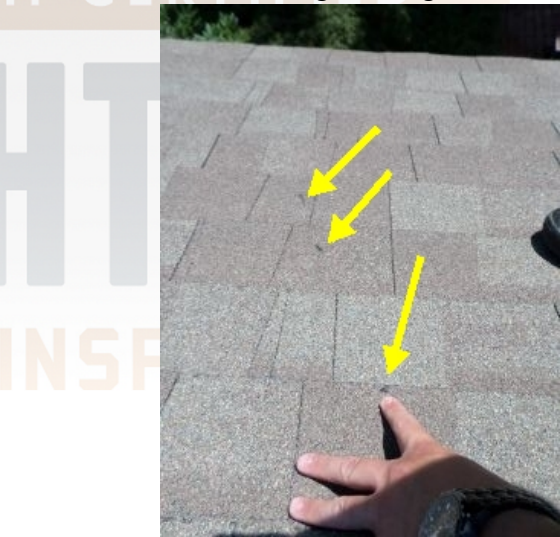
Note: Roof covering damage was observed.

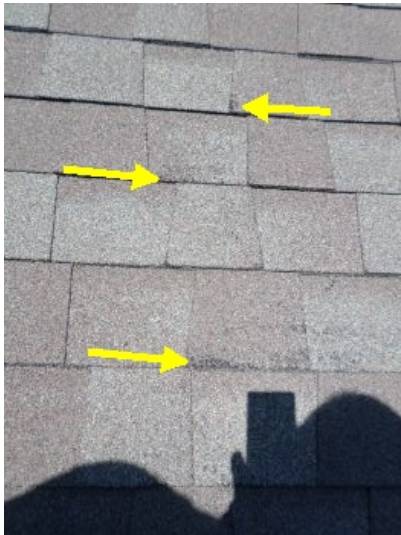
Note: deterioration of the roof covering observed.

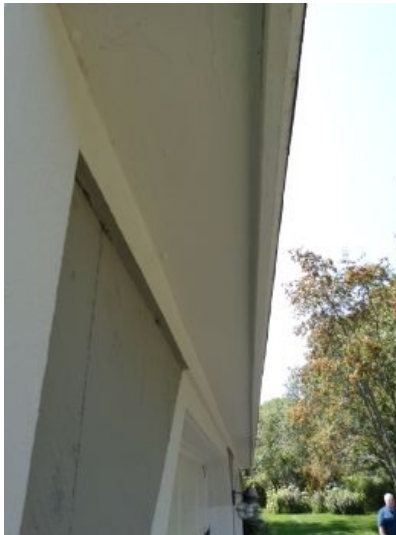
Will there appeared to be no ventilation installed on the garage. This could lead to excess moisture due to condensation buildup also may reduce the life expectancy of the roof covering due to excess heat. Consider contacting a qualified contractor to add the necessary ventilation.

- IMPROVE: Additional venterty to the soffits will extend the life of the roof covering.

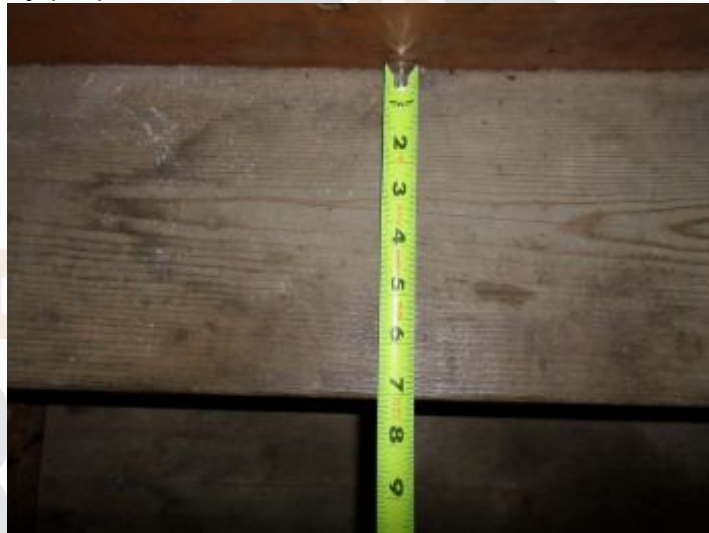
Note: Stairs, not installed to today's standards. Trade should be a minimum of 10 inches.

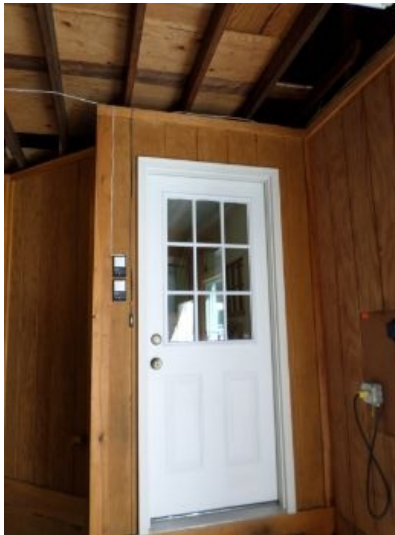
- The door between the garage & house is not a fire rated door. This may not have been required when originally built. Fire doors are fundamental to the integrity of fire barriers which provide resistance to the spread of fire, smoke, and toxic gasses. This means that should a fire occur in the garage, this door does not afford protection until fire-rescue people arrive. This door should be replaced with a fire rated door.

The door separating the garage from the living space Did not appear to be fire rated or self-closing. This may not of been required when the house was built, but consider upgrading for safety reasons.
